## Management Report

Wolcott Public Schools  
Tyrrell Middle School  
500 Todd Road, Wolcott, CT

**Section:** Main Roof  
**Size:** 93532  
**Overall Grade:** C

**Inspection Date:** 04/18/2024  
**Inspector:** Bob Metivier

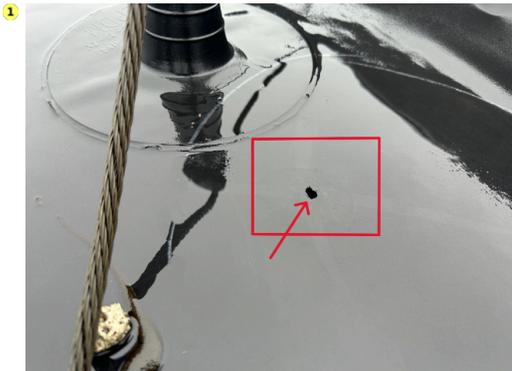
**General - Punctures - Rips - Tears (Emergency)**

Quantity: 1 EA

These deficiencies are typically caused by foot traffic, or mechanical work. Located on the 7th & 8th Grade Building.

The area surrounding the deficiency must be cleaned. A new piece of waterproofing membrane would be installed and sealed per industry standards.

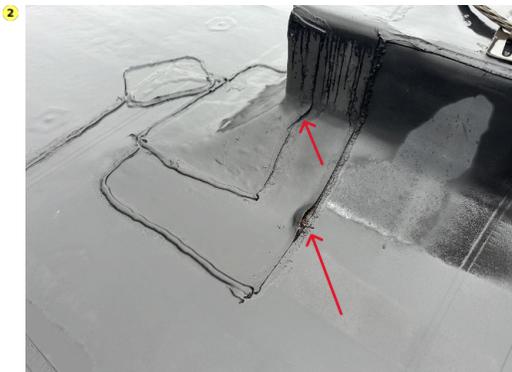
**General - Corner Flashing Open (Remedial)**

Quantity: 1 EA

Corner detail is open and needs to be sealed. Located on the 7th & 8th Grade Building.

We will clean and prime the area and install patch to ensure water tightness.

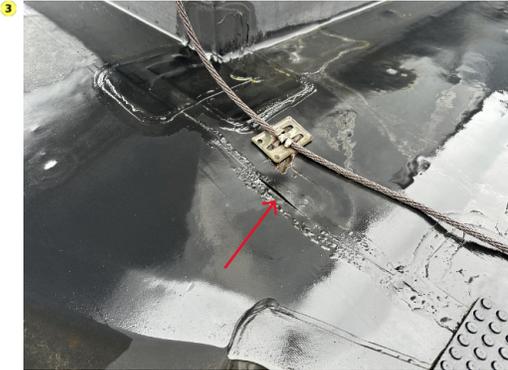
**General - Open Seams (Emergency)**

Quantity: 1 EA

Open seams in the waterproofing membrane are typically caused by failing seam adhesives coupled with membrane shrinkage and stress on the seams. Located on the 7th & 8th Grade Building.

The area surrounding the open seam must be cleaned. A new piece of waterproofing membrane would be installed and sealed per industry standards.

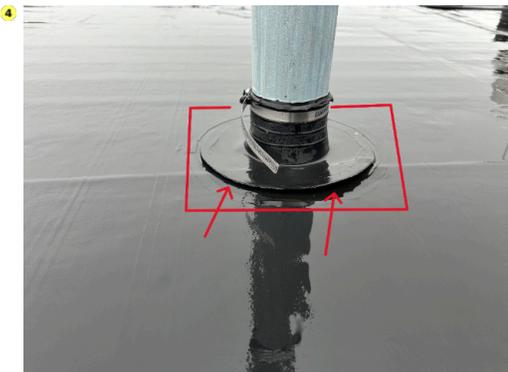
**General - Improper Installation (Remedial)**

Quantity: 1 EA

The original installation of this detail was done improperly and not per industry standards. The pipe boot is not adhered to the membrane. Located on the 7th & 8th Grade Building.

Remove the existing detail and install a new detail per the industry and manufacturers recommendations and details.

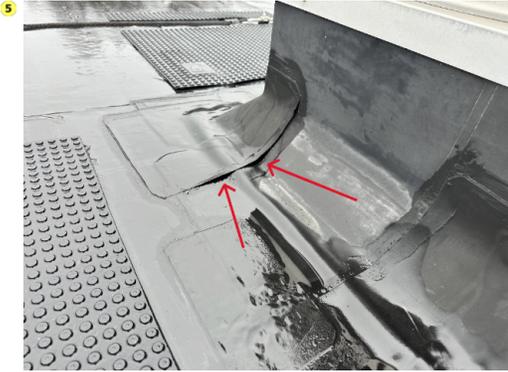
**General - Corner Flashing Open (Remedial)**

Quantity: 1

Corner detail is open and needs to be sealed. Located on the 7th & 8th Grade Building.

We will clean and prime the area and install patch to ensure water tightness.

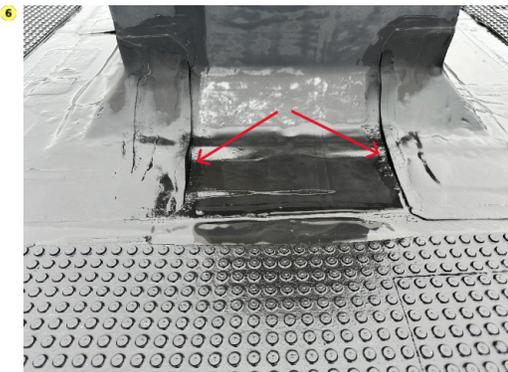
**General - Corner Flashing Open (Remedial)**

Quantity: 2 EA

Corner detail is open and needs to be sealed. Located on the 7th & 8th Grade Building.

We will clean and prime the area and install patch to ensure water tightness.

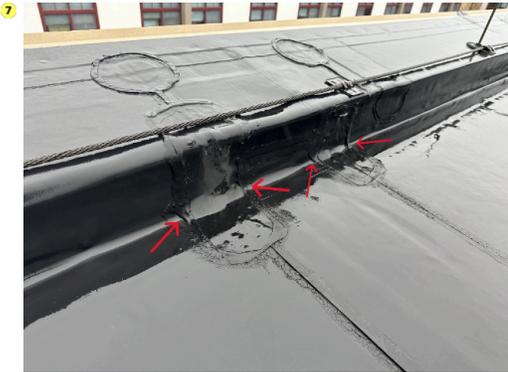
**General - Open Flashing (Remedial)**

Quantity: 2 EA

Open flashings can be caused by membrane shrinkage, or the simple aging and failure of the original flashing. Located on the 7th & 8th Grade Building.

Clean and prime area, install new patch to ensure water tightness.

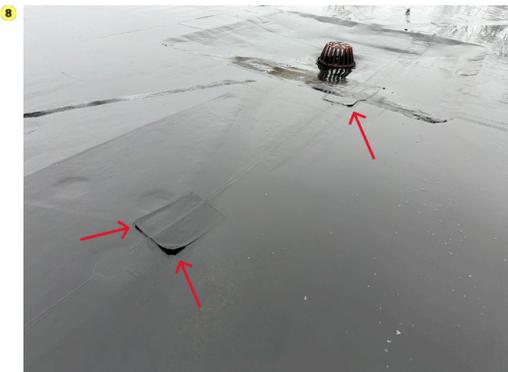
**General - Uncured Flashing Failure (Remedial)**

Quantity: 8 EA

Open flashings can be caused by membrane shrinkage, or the simple aging and failure of the original flashing. Located on the 7th & 8th Grade Building.

Depending on the severity of the deterioration of the flashing, they either will need to be removed completely and new flashing installed or the existing flashing must be re-sealed with a secondary piece of waterproofing material.

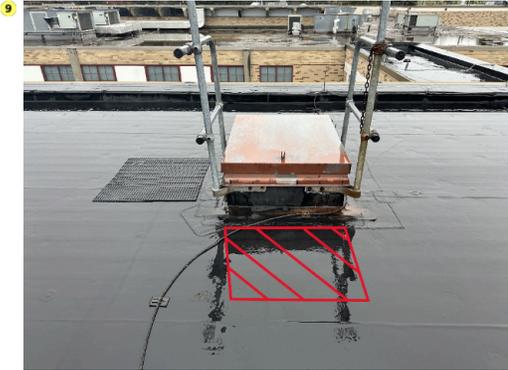
**General - Missing walkpads/ slip sheets (Remedial)**

Quantity: 1 EA

Roof protection mats are missing at rooftop access points The original walkpad was installed on the wrong side. Located on the 7th & 8th Grade Building.

Clean, prime and install walkway protection.

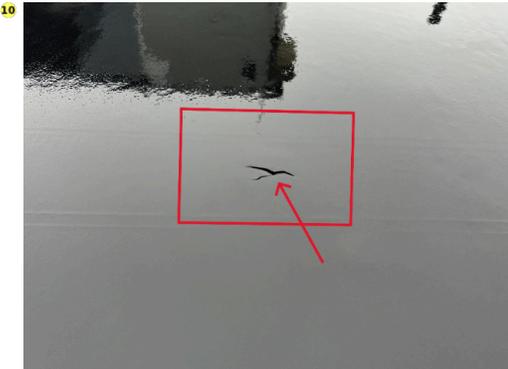
**General - Punctures - Rips - Tears (Emergency)**

Quantity: 1 EA

These deficiencies are typically caused by foot traffic, or mechanical work. Located on the 7th & 8th Grade Building.

The area surrounding the deficiency must be cleaned. A new piece of waterproofing membrane would be installed and sealed per industry standards.

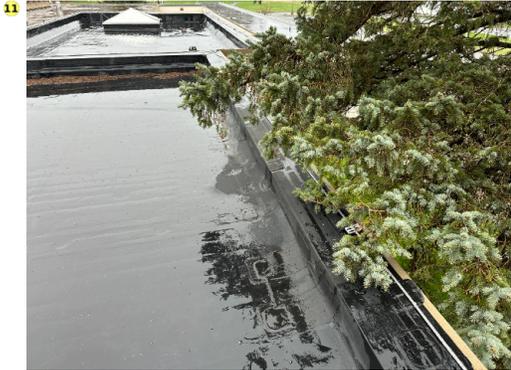
**General - (Remedial)**

Quantity: 1 EA

A tree is overhanging the roof. It allows for easy access for animals and poses a puncture hazard to the membrane. Located near front entrance

Trim tree back from roof edge

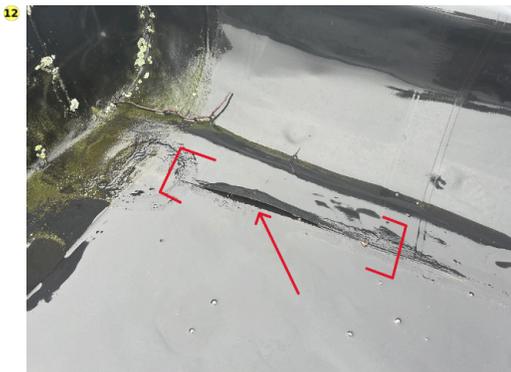
**General - Open Seams (Remedial)**

Quantity: 1 EA

Open seams in the waterproofing membrane are typically caused by failing seam adhesives coupled with membrane shrinkage and stress on the seams. Located on the South corner of the Gym Building.

The area surrounding the open seam must be cleaned. A new piece of waterproofing membrane would be installed and sealed per industry standards.

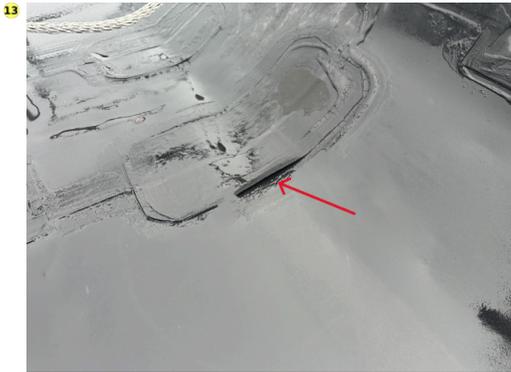
**General - Uncured Flashing Failure (Remedial)**

Quantity: 1 EA

Open flashings can be caused by membrane shrinkage, or the simple aging and failure of the original flashing. Located on the Gym Building.

Depending on the severity of the deterioration of the flashing, they either will need to be removed completely and new flashing installed or the existing flashing must be re-sealed with a secondary piece of waterproofing material.

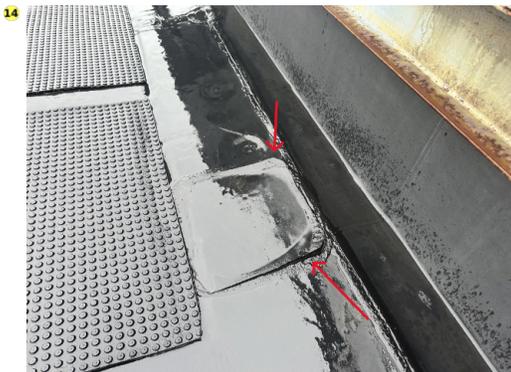
**General - Uncured Flashing Failure (Remedial)**

Quantity: 1 EA

Open flashings can be caused by membrane shrinkage, or the simple aging and failure of the original flashing. Located on the Gym Building.

Depending on the severity of the deterioration of the flashing, they either will need to be removed completely and new flashing installed or the existing flashing must be re-sealed with a secondary piece of waterproofing material.

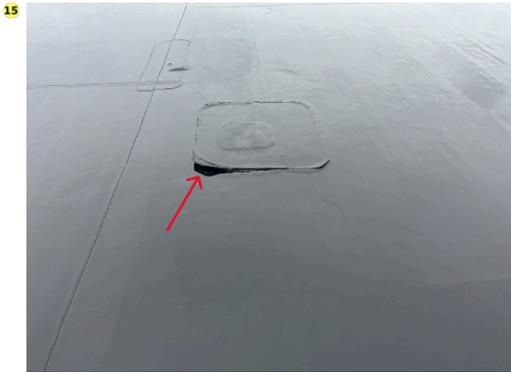
**General - Uncured Flashing Failure (Remedial)**

Quantity: 1 EA

Open flashings can be caused by membrane shrinkage, or the simple aging and failure of the original flashing. Located on the Gym Building.

Depending on the severity of the deterioration of the flashing, they either will need to be removed completely and new flashing installed or the existing flashing must be re-sealed with a secondary piece of waterproofing material.

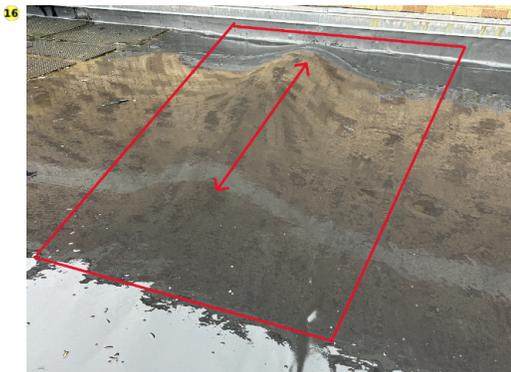
**General - Damaged Insulation (Remedial)**

Quantity: 32 Sq Ft

The roof insulation is damaged due to foot traffic, water infiltration, or age. There is insulation that is buckling up. Located at the base of the Gym

Replace damaged insulation and install new waterproofing membrane. In high foot traffic areas we recommend utilizing high density insulation.

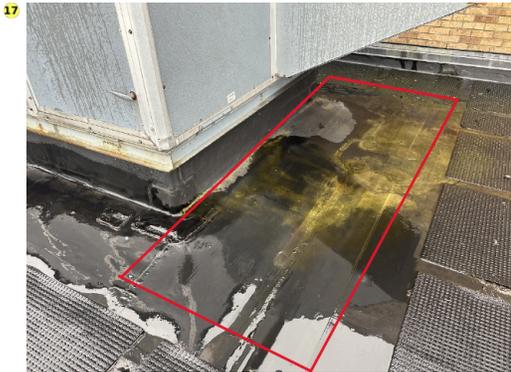
**General - Damaged Insulation (Remedial)**

Quantity: 32 Sq Ft

The roof insulation is damaged due to foot traffic, water infiltration, or age. This section is severely saturated with moisture. Located at the base of the Gym

Replace damaged insulation and install new waterproofing membrane. In high foot traffic areas we recommend utilizing high density insulation.

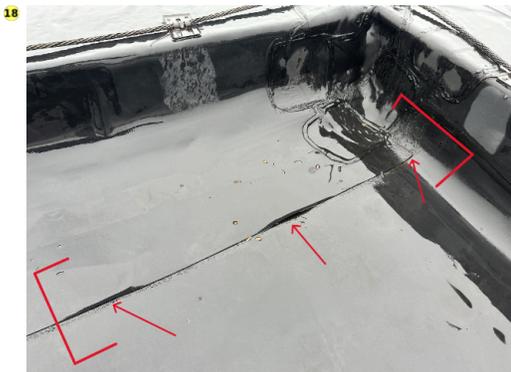
**General - Open Seams (Remedial)**

Quantity: 5 LF

Open seams in the waterproofing membrane are typically caused by failing seam adhesives coupled with membrane shrinkage and stress on the seams. Located on the Northeast corner of the Auditorium.

The area surrounding the open seam must be cleaned. A new piece of waterproofing membrane would be installed and sealed per industry standards.

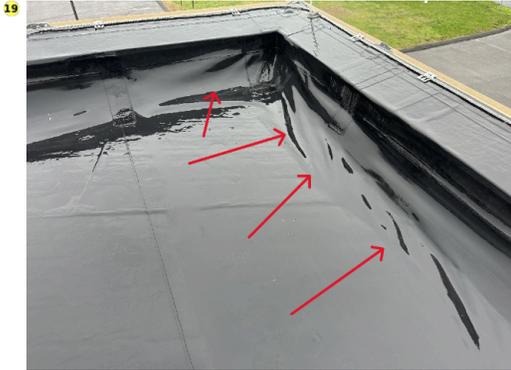
**General - Bridging (Remedial)**

Quantity: 10 LF

Bridging of the membrane is caused by the overall shrinking that takes place over time or failure of the batten detail. The shrinking of the membrane is causing it to pull away from the perimeter walls/curbs and causes stress on the roof flashing. Located at the East end of the Music hallway.

The existing membrane needs to be cut and allowed to relax. Install a new batten detail and a new piece of waterproofing membrane.

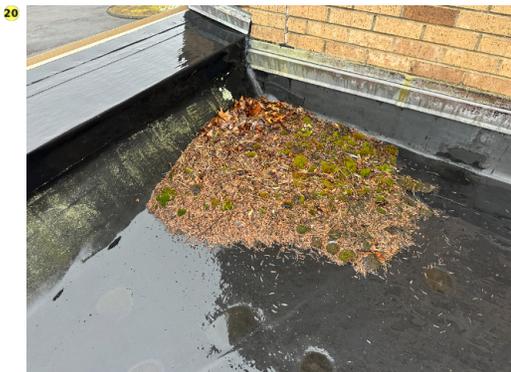
**General - Organic Debris (Remedial)**

Quantity: 1 EA

Organic debris (leaves, branches, animal feces, sand, sea shells, etc).

Organic debris should be removed as it can potentially cause roof damage and impede the drainage of the roof system. (Animal feces, carcasses, and feathers should be removed by others)

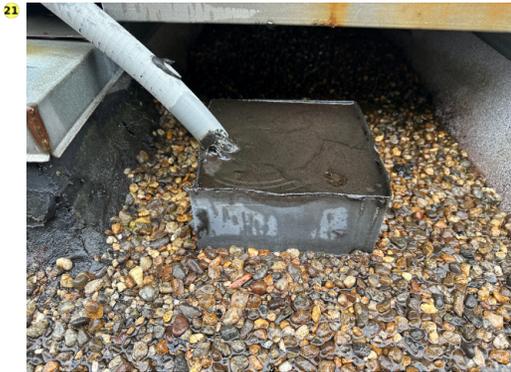
**General - Pourable Sealer Shrinkage (Remedial)**

Quantity: 1 EA

Pourable sealer inside pitch pocket has shrunk and allowing water in

Prime the area and top off sealer

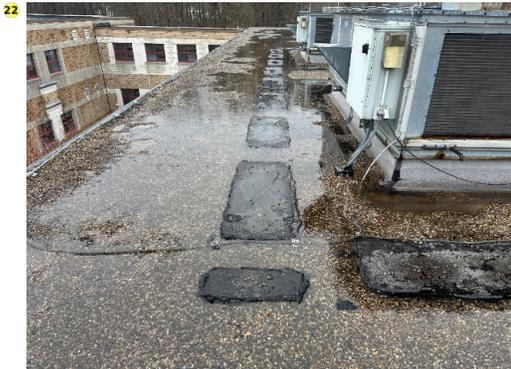
**General - Ponding (Remedial)**

Quantity: 1 EA

A ponding water condition is typically due to a flaw in how the original roof was designed to flow to drains or the underlying insulation has collapsed due to age or weight and created a low lying area on the roof which is now holding water.

A ponding water condition is best corrected during a re-roof project. Outside of removing the existing insulation and starting with a new roof design, ponding water is difficult to correct.

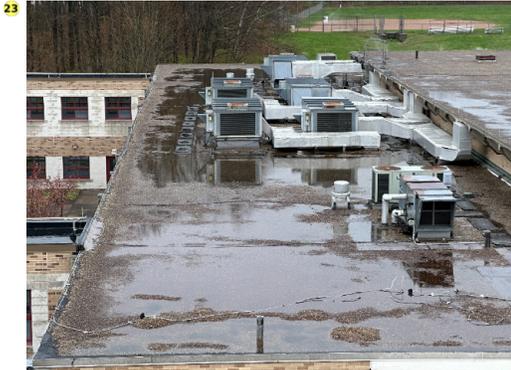
**General - Ponding (Remedial)**

Quantity: 1 EA

A ponding water condition is typically due to a flaw in how the original roof was designed to flow to drains or the underlying insulation has collapsed due to age or weight and created a low lying area on the roof which is now holding water.

A ponding water condition is best corrected during a re-roof project. Outside of removing the existing insulation and starting with a new roof design, ponding water is difficult to correct.

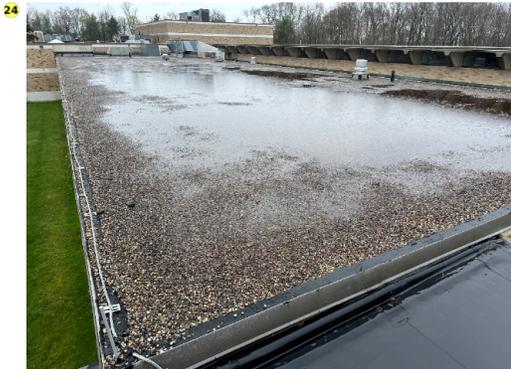
**General - Ponding (Remedial)**

Quantity: 1 EA

A ponding water condition is typically due to a flaw in how the original roof was designed to flow to drains or the underlying insulation has collapsed due to age or weight and created a low lying area on the roof which is now holding water.

A ponding water condition is best corrected during a re-roof project. Outside of removing the existing insulation and starting with a new roof design, ponding water is difficult to correct.

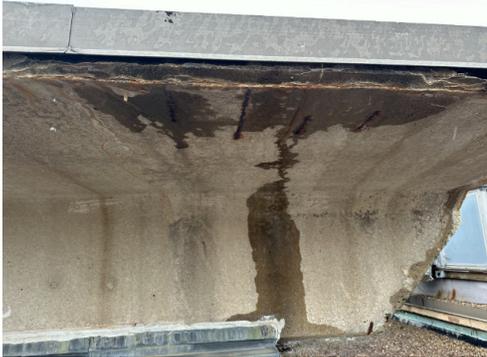
**General - (Remedial)**

Quantity: 1 EA

The ponding water on the Media Center is spilling over the edge and damaging the underneath side of the concrete overhang

The only way to correct this is during a reroofing project or install additional drains to alleviate ponding.
