## Management Report

Wolcott Public Schools  
Tyrrell Middle School  
500 Todd Road, Wolcott, CT

**Section:** Main Roof  
**Size:** 93532  
**Overall Grade:** C

**Inspection Date:** 04/18/2024  
**Inspector:** Bob Metivier

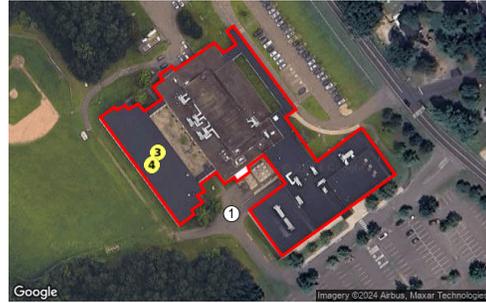
**General - Open Seams (Emergency)**

Quantity: 1 EA

**Deficiency:**

Open seams in the waterproofing membrane are typically caused by failing seam adhesives coupled with membrane shrinkage and stress on the seams. Located on the 7th & 8th Grade Building.

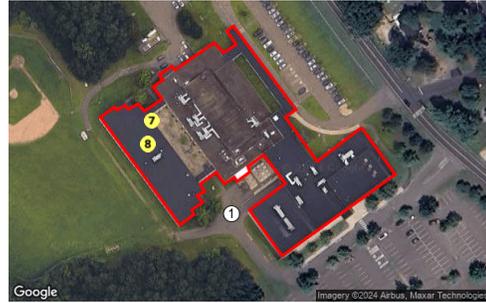
**General - Open Flashing (Remedial)**

Quantity: 2 EA

**Deficiency:**

Open flashings can be caused by membrane shrinkage, or the simple aging and failure of the original flashing. Located on the 7th & 8th Grade Building.

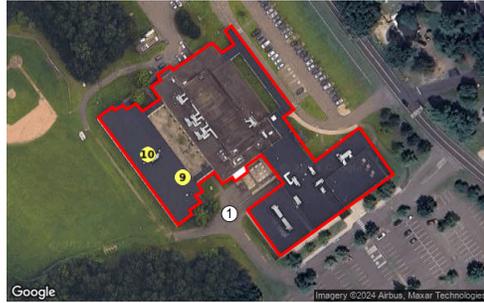
**General - Missing walkpads/ slip sheets (Remedial)**

Quantity: 1 EA

**Deficiency:**

Roof protection mats are missing at rooftop access points The original walkpad was installed on the wrong side. Located on the 7th & 8th Grade Building.

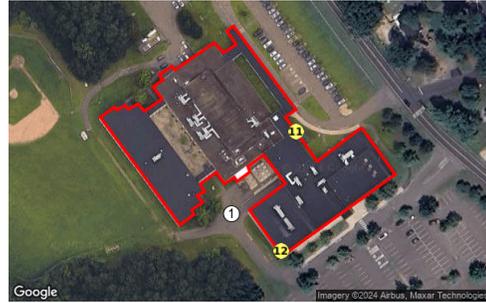
**General - (Remedial)**

Quantity: 1 EA

**Deficiency:**

A tree is overhanging the roof. It allows for easy access for animals and poses a puncture hazard to the membrane. Located near front entrance

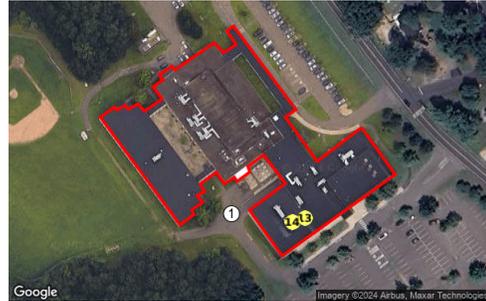
**General - Uncured Flashing Failure (Remedial)**

Quantity: 1 EA

**Deficiency:**

Open flashings can be caused by membrane shrinkage, or the simple aging and failure of the original flashing. Located on the Gym Building.

Depending on the severity of the deterioration of the flashing, they either will need to be removed completely and new flashing installed or the existing flashing must be re-sealed with a secondary piece of waterproofing material.

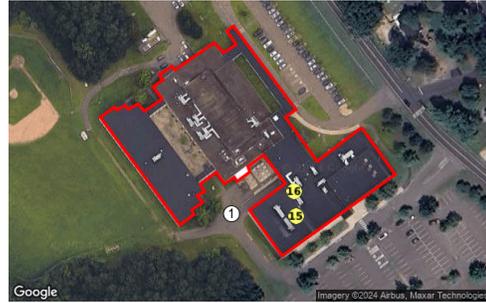
**General - Uncured Flashing Failure (Remedial)**

Quantity: 1 EA

**Deficiency:**

Open flashings can be caused by membrane shrinkage, or the simple aging and failure of the original flashing. Located on the Gym Building.

Depending on the severity of the deterioration of the flashing, they either will need to be removed completely and new flashing installed or the existing flashing must be re-sealed with a secondary piece of waterproofing material.

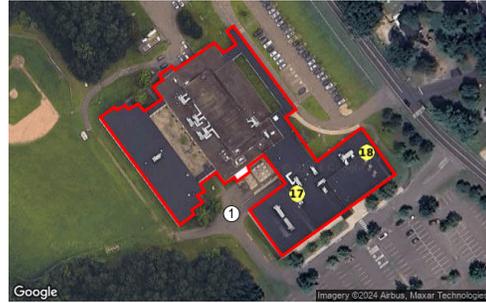
**General - Damaged Insulation (Remedial)**

Quantity: 32 Sq Ft

**Deficiency:**

The roof insulation is damaged due to foot traffic, water infiltration, or age. This section is severely saturated with moisture. Located at the base of the Gym

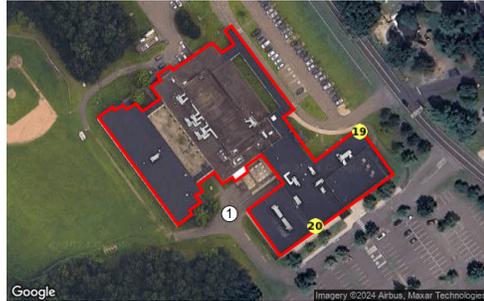
**General - Bridging (Remedial)**

Quantity: 10 LF

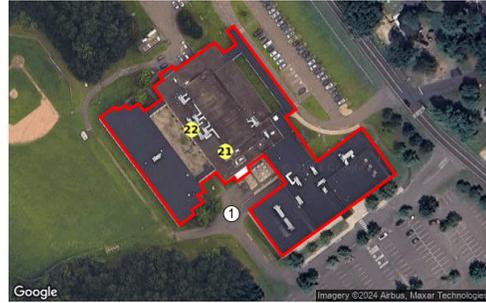
**General - Pourable Sealer Shrinkage (Remedial)**

Quantity: 1 EA

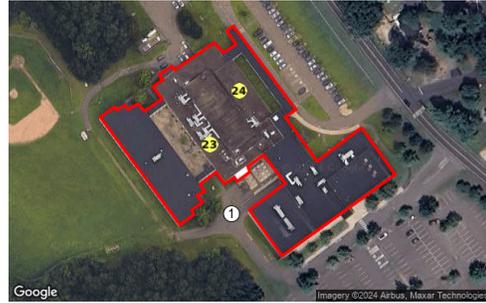
**General - Ponding (Remedial)**

Quantity: 1 EA
